Nanoscale characterization of Co and Co-B catalytic coatings before and after catalytic tests for the sodium borohydride hydrolysis

Keywords: Co catalysts, Hydrogen storage, STEM, EELS, catalytic coatings, sodium borohydride

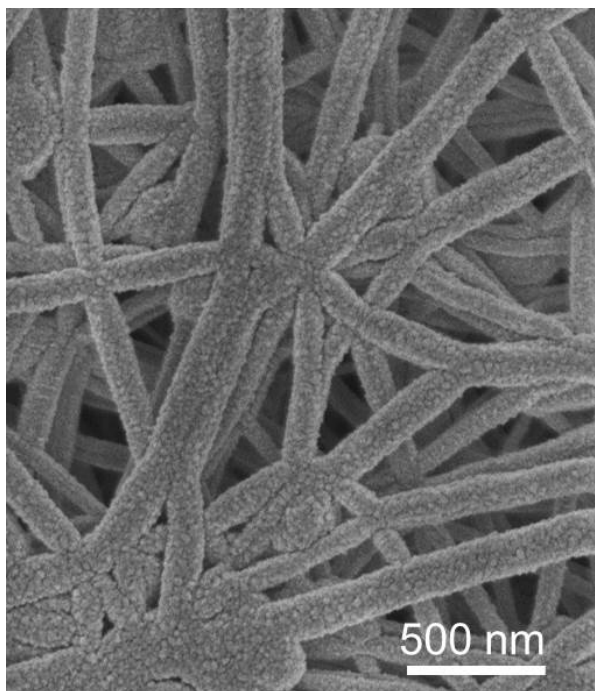
SEM image of a Co-thin film on polymeric membrane before the catalytic test.

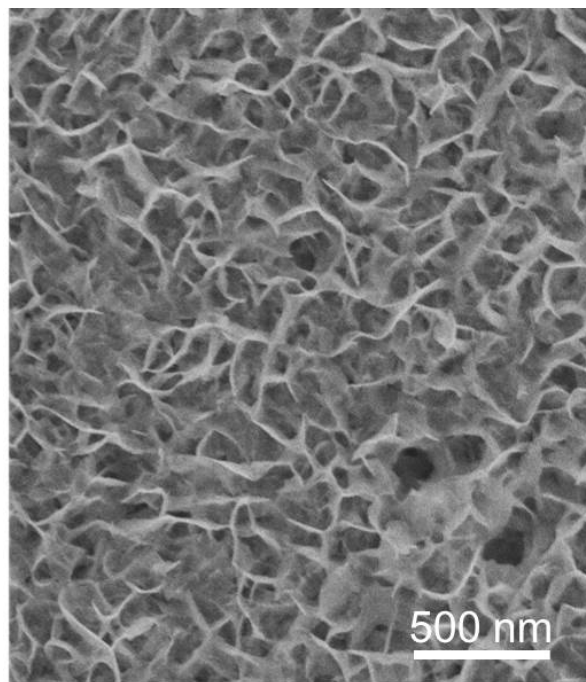
SEM image of a Co-thin film on polymeric membrane after the catalytic test

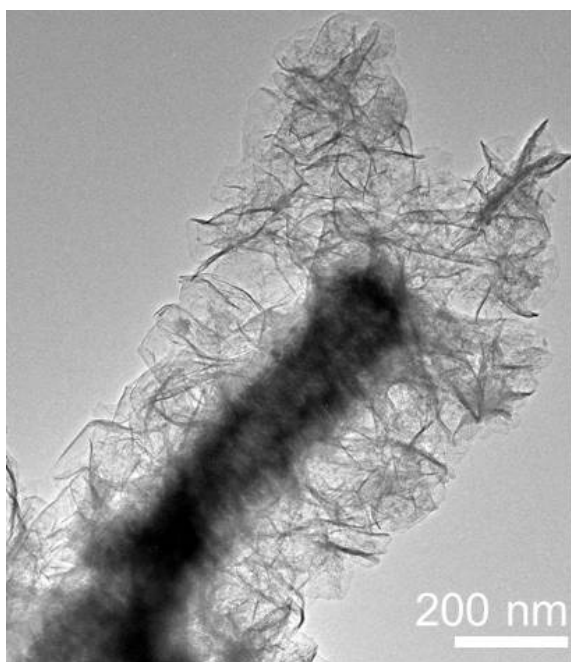
TEM image of a Co thin film supported on polymeric membrane after the catalytic test.

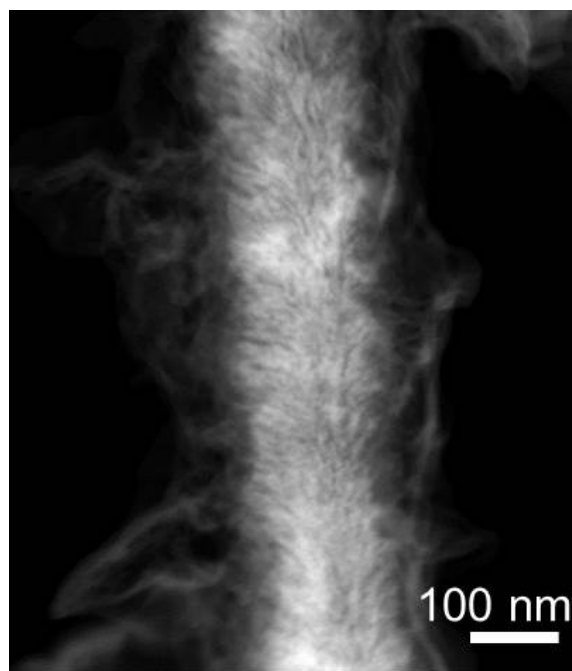
STEM image of a Co thin film supported on polymeric membrane after the catalytic test.
